# **Debris/Ice/TPS Assessment and Integrated Photographic Analysis of Shuttle Mission STS-90**

*Gregory N. Katnik  
Process Engineering/Mechanical System Division/ET-SRB Branch,  
Kennedy Space Center, Florida*

**17 April 1998**

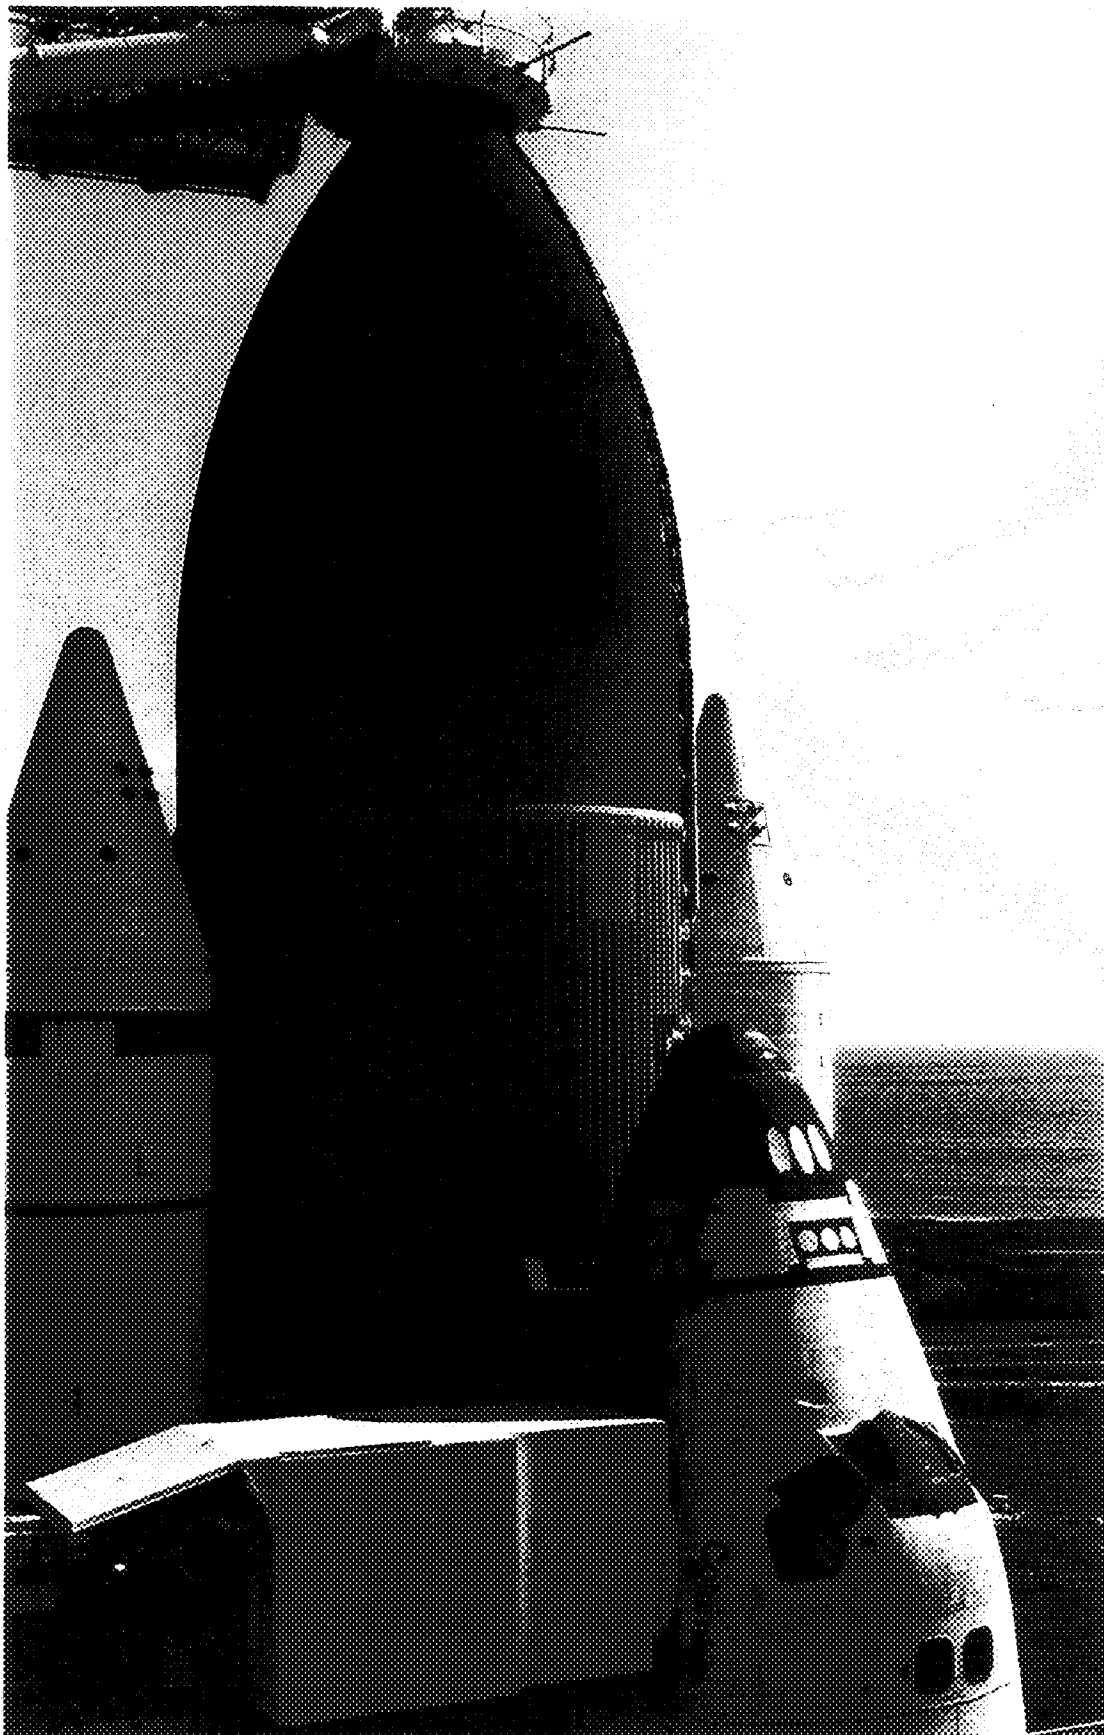
**Photo 2: STS-90 Ready for Launch**

OV-102 Columbia (25th flight), ET-91 (LWT 84), and BI-094 SRB's. The Final Inspection Team observed no ice, frost, or condensate on the LO2 tank acreage. TPS surface temperatures averaged 65 degrees F.

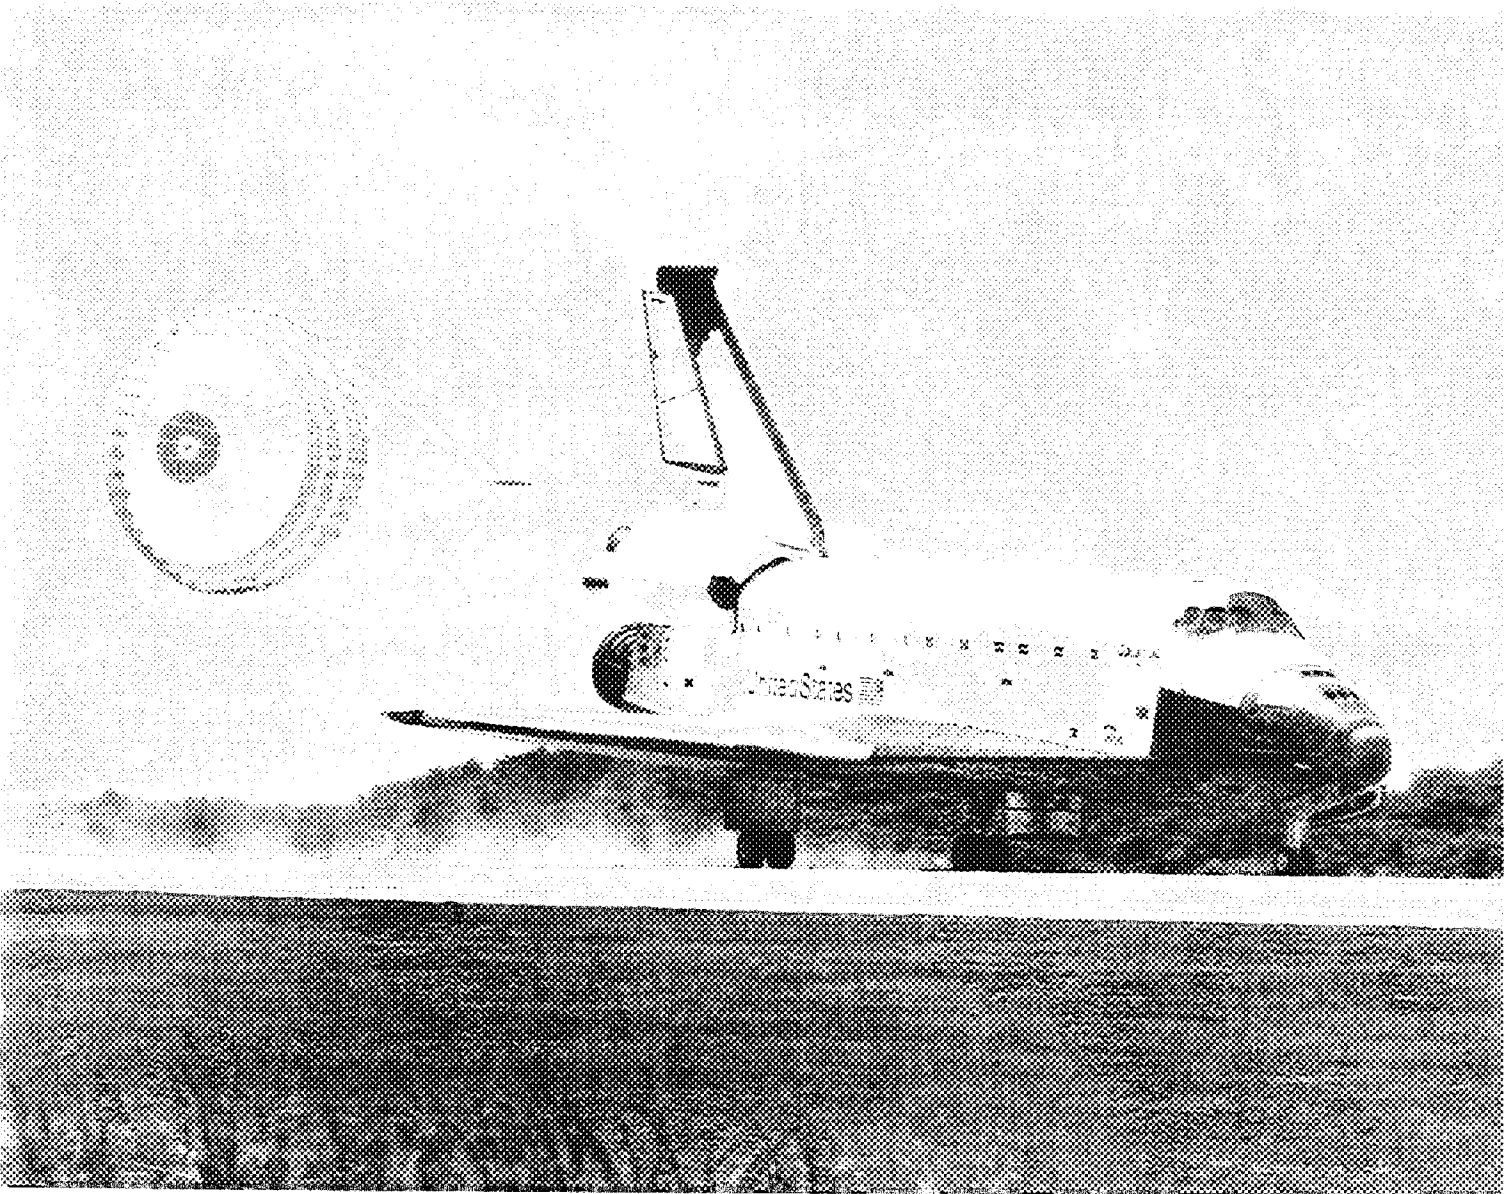
**Photo 21: Landing**

After the 12:09 p.m. local/eastern time landing on 3 May 1998, a post landing inspection of OV-102 Columbia was conducted at the Kennedy Space Center on SLF runway 33.
